RE: February Monthly Report
1.5 Mile Reach Removal Action
GE-Pittsfield/Housatonic River Site

**GE-Pittsfield/Housatonic River Project 1.5 Mile Removal Action
Pittsfield, MA**

Figure 1
1.5 Mile Removal Action
Site Map (Map 1 of 2)
February 2006 Monthly Report

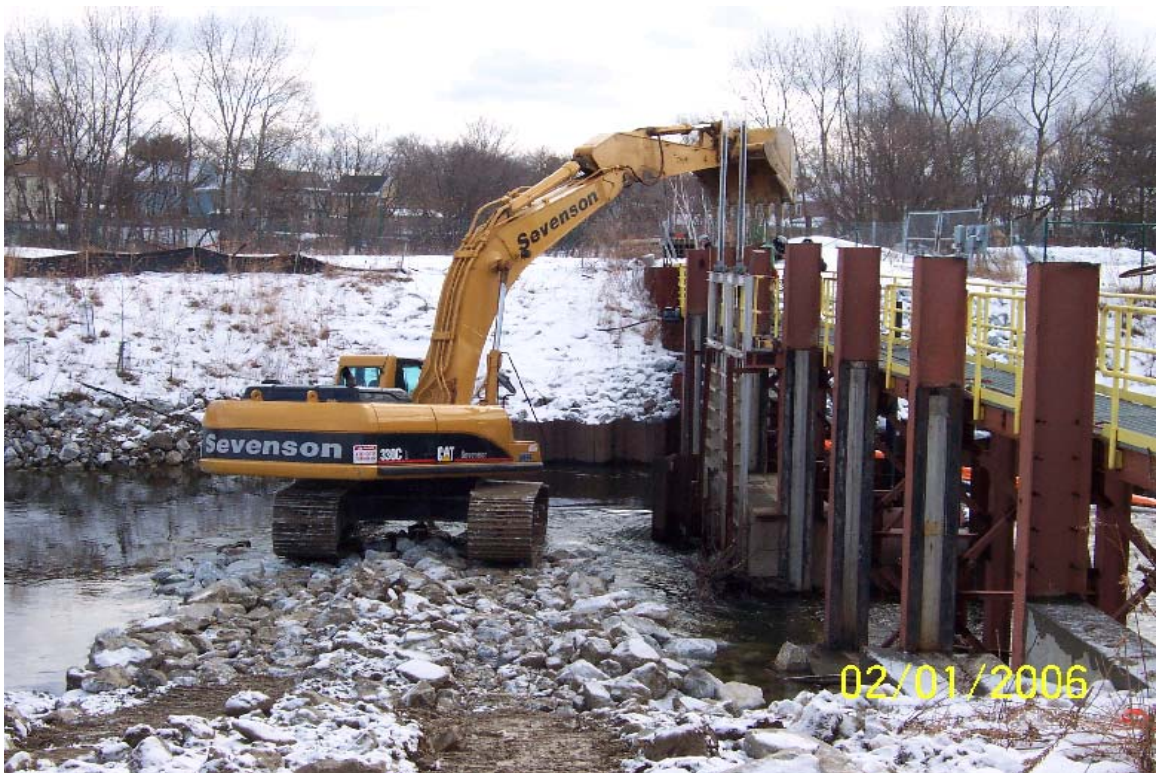
Photograph 1 – Removal of the Temporary River Diversion Dam

Also, by the end of January 2006, activities associated with the demolition of the temporary river diversion dam were initiated. During the month of February, the demolition of the temporary

dam continued. The slide gates, the walkway, the railings and other components of the dam were removed. The vertical beams and the upper section steel components of the dam were cut with torches into manageable pieces and stockpiled on site for disposal as scrap metal. The concrete components of the dam were then removed by using an excavator with a concrete hammer. The concrete foundation was broken down in place into pieces and removed carefully from the riverbed so it would not disturb the underlying layer of backfill. The concrete pieces were then transferred to the stockpile management area where they will be sampled. The two 54-inch pipe spool pieces that were embedded in the concrete were also removed and stockpiled on site.

Next, a 100-ton crane was mobilized to the site to remove the trash rack located upstream of the dam and the sheetpile that was located on the riverbank and below the concrete cap in the riverbed. The crane was assembled and load tests were performed, all the tests passed and the crane was approved for use. The sheetpile and trash rack removal was initiated on the west side of the river first, then the crane was relocated to the east side of the river and the sheetpile and the trash rack were removed from the east riverbed and riverbank. Once the sheetpile was removed and the demolition of the dam structure was complete, both the riverbed and the riverbank were restored with riprap to meet the design backfill configurations for those areas. Twelve-inch riprap was placed in the riverbed and 18-inch riprap was placed on the riverbank up to elevation 976.0 AMSL. The riverbank above elevation 976.0 AMSL will be backfilled with a layer of common fill and topsoil at a later date. In addition, 18-inch riprap wedge was placed over the exposed permanent sheetpile retaining wall located on the east side of the river. Also, once the dam structure was removed, the required river enhancement structures were placed in the riverbed near the location of the dam.

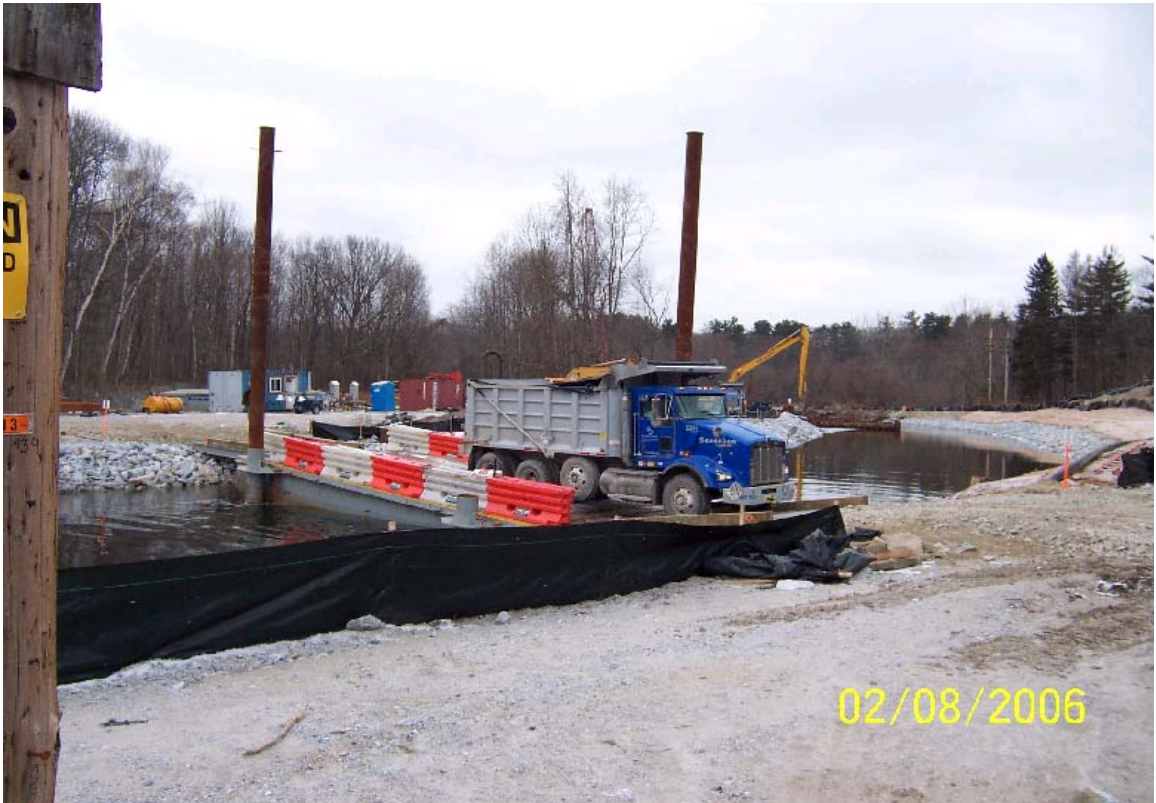
Photograph 2 – Floating Barge River Crossing

This time, the floating barge river crossing was installed directly upstream of Cells 39S and 40S. The barge is composed of two forty-foot by ten-foot barge sections, which overlap one another by a lip and are connected together by pins. Two vertical spuds were installed through the spud pockets on opposite corners of the barge for stabilization purposes. Fold out ramps were connected to the barge by pins. The other end of the ramps extended to the access roads on both sides of the river. Road barriers were placed along the outside edges of the barge and eight by eight wood curbs were placed on the outside edges of the ramps.

Once the barge crossing was in place several load tests were completed over the barge with 75% full, and 100% full trucks. All load tests passed and the use of the floating barge crossing was approved for use.

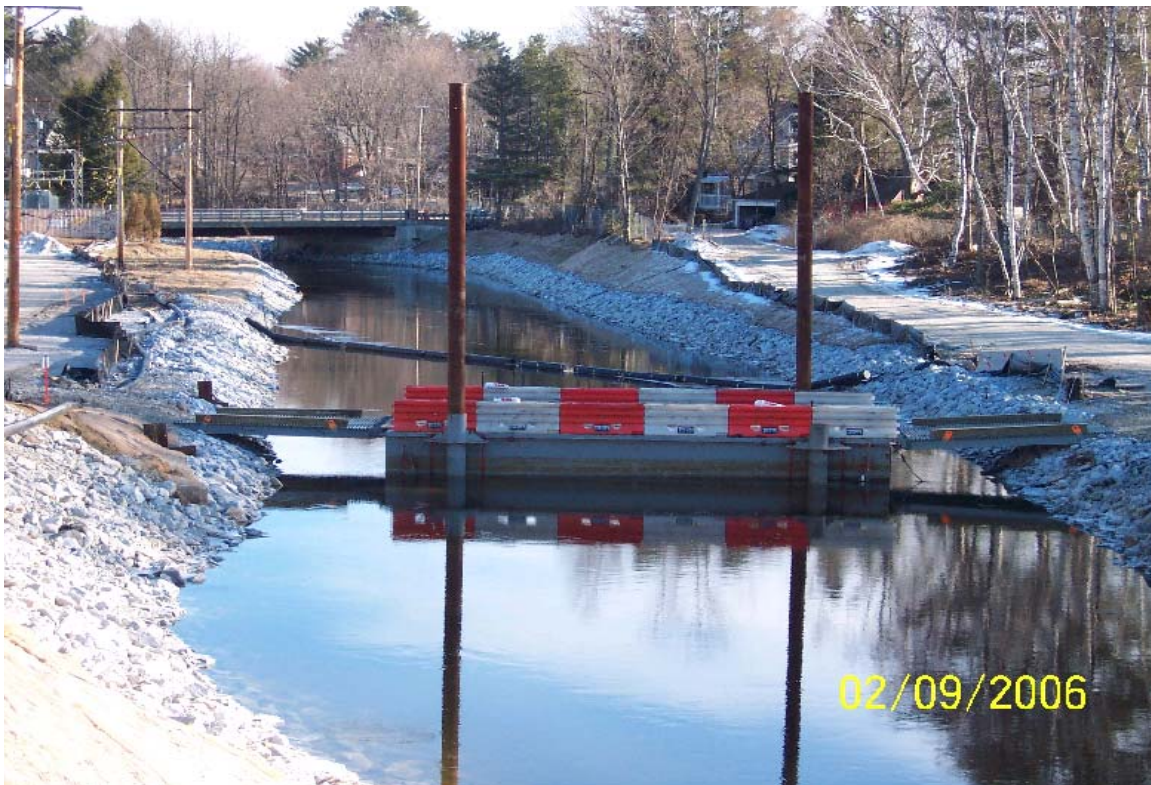
Photograph 3 – Floating Barge River Crossing

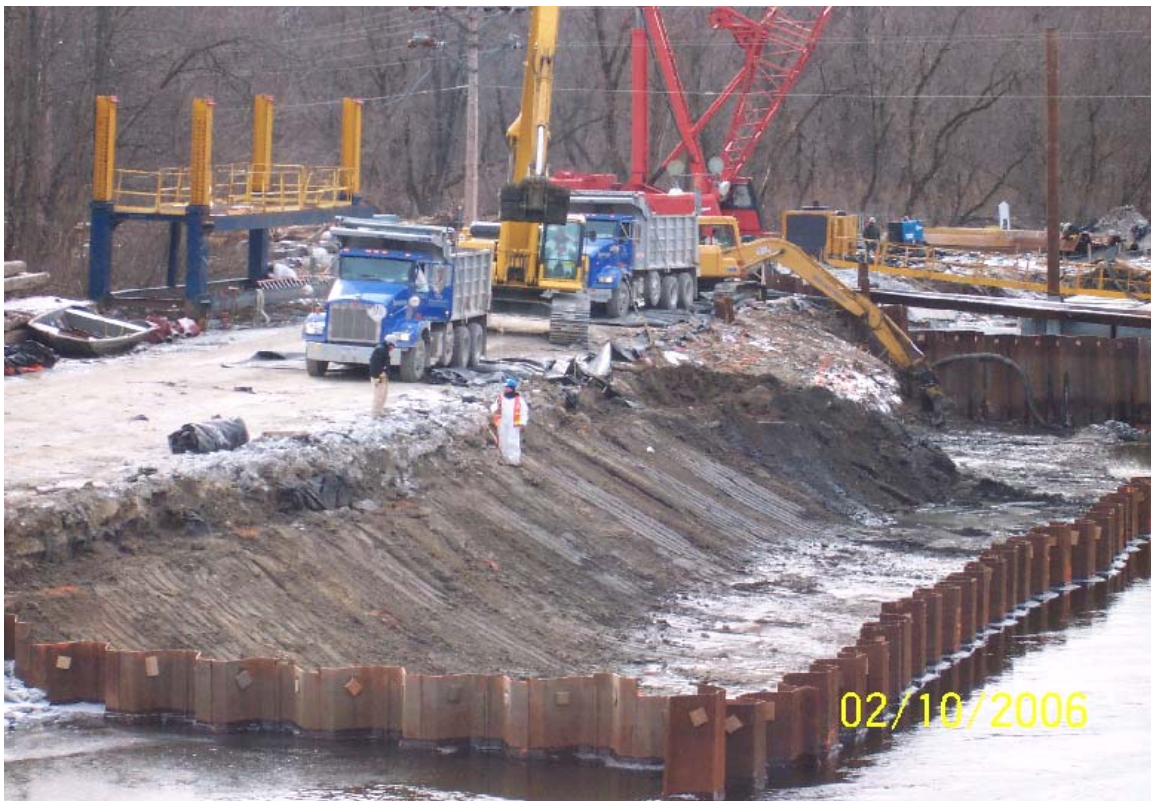
Photograph 4 – Excavation Activities in Cell 41

Once Cell 41 was isolated, the dewatering activities were completed. The water greater than 6-inches in depth was pumped directly back to the river. Once the water depth reached 6-inches, it was pumped to the water treatment system (WTS). Sumps and swales were installed to help in the dewatering process. Once dewatering was completed, the survey contractor completed the delineation of non-TSCA and TSCA excavation areas in Cell 41 and excavation activities in Cell 41 were completed. A small section of the floodplain in Cell 41 adjacent to the top of riverbank where GE anticipates performing subsequent remediation on floodplains was remediated and restored by EPA's contractors. The excavated TSCA material was transported to Building 65 stockpile management area. The non-TSCA material not characterized for off-site disposal was transported to Area 64C north, Area 64D north and Area 64D south stockpile management areas. (See the attached Table 1 for amount of material excavated during the month of February and Table 2 for the amount of material excavated to date)

The surveyors monitored the excavation activities in Cell 41 to ensure appropriate design excavation depths were achieved.

The total amount of material excavated from Cell 41 in the "GE floodplain area" was 11 cy. GE will be responsible for the excavation, backfill, and OPCA disposal costs for the 11 cy of material.

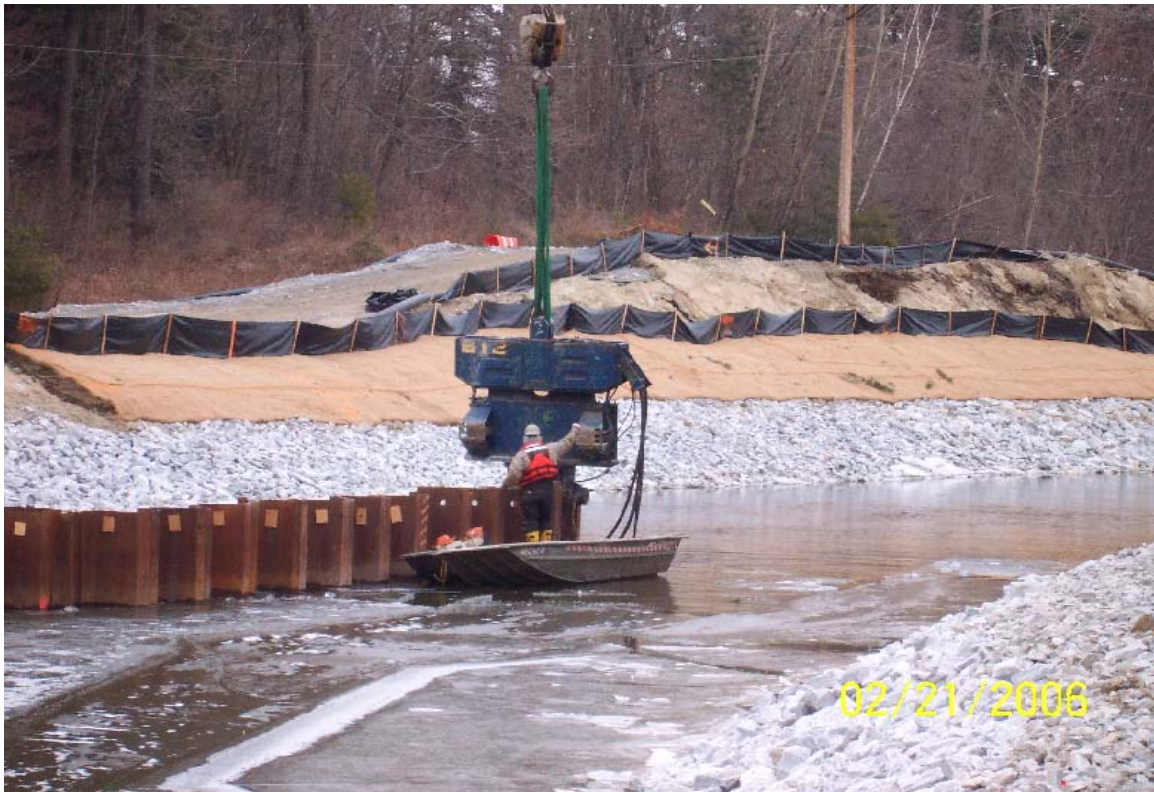
Photograph 5 – Removal of the Cell 41/42 Sheetpile Centerline Wall

While excavation activities were ongoing in lower Cell 44, the sheetpile containment walls for Cell 45 were installed. A sewer siphon structure is located beneath the Cell 45 riverbed sediment. The sheets were driven very carefully to embed on top of the sewer siphon structure without damaging the structure. Cell 45 is the last cell associated with the 1.5 mile remediation activities and there will be no riverbed or riverbank excavation beyond Cell 45. Once the installation of the walls in Cell 45 was complete, the removal of the Cell 41 upstream sheetpile cutoff wall and the removal of the Cells 41/42 centerline wall were completed.

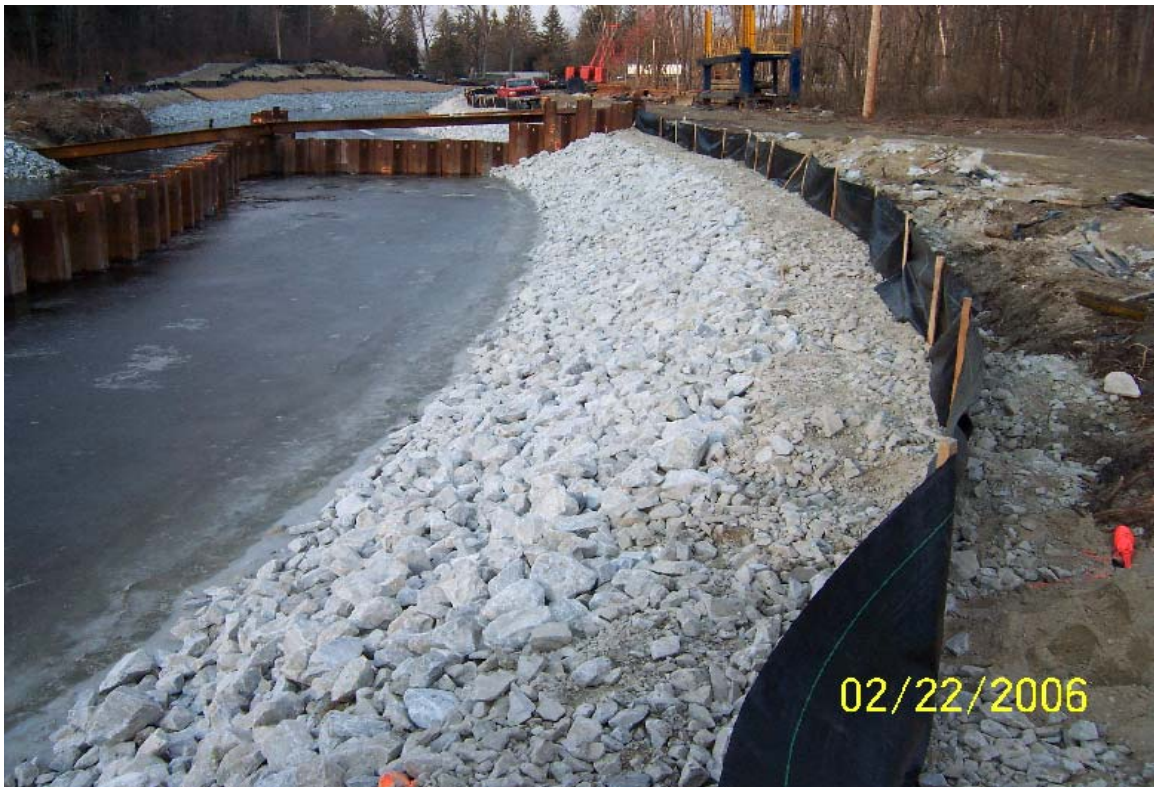
Photograph 6 – Cell 44-Upper Backfilling Activities Completed

The riverbed and riverbanks of Cell 44 were backfilled as follows: The riverbed in Cell 44 did not require common fill. However due to the significant ground water infiltration, filter material type I was placed and worked into the riverbed to provide a stable base for the six-inch layer of filter material type III which was placed next. Then, a ten-inch layer of filter material type I, and a fourteen-inch layer of 9-inch riprap were installed. The riverbanks in Cell 44 were backfilled with common fill to the design grade. Then, a six-inch layer of filter material type III, followed by a ten-inch layer of filter material type I and an eighteen-inch layer of 12-inch riprap were placed up to elevation 965.0 feet above mean sea level AMSL.

The riverbanks beyond elevation 965.0 feet AMSL were backfilled with common fill to within 6-inches of final grade. The common fill was installed in twelve-inch horizontal lifts and compacted to meet the 95% compaction requirement. Due to the upcoming remediation in the "GE floodplain area" adjacent to Cell 44, the topsoil, herbaceous seed and erosion control blankets will be placed at a later date.

The surveyors monitored the backfilling activities in Cell 44 to ensure appropriate design backfill grades were achieved. Upon completion of the backfilling activities in Cell 44, final restoration verification survey was completed.
